**WASHINGTON STATE PATROL**  
**CRIMINAL INVESTIGATION DIVISION**  
*Investigative Report*

**FILE TITLE**  
Attempted Theft 1<sup>st</sup> degree

# 2013 Ford Edge SEL AWD

## SYNC Gen 1 Version 3

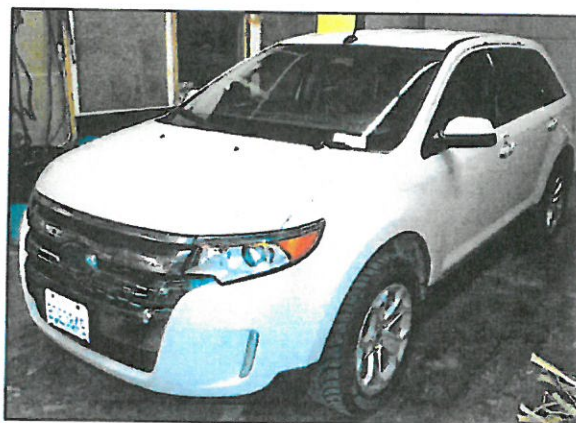
Image 1: 2013 Ford Edge, VIN: 2FMDK4JC9DBB31410.

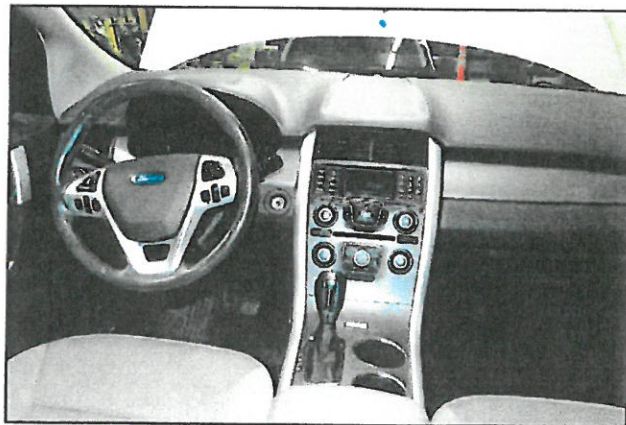
Image 2: Interior of 2013 Ford Edge with Sync Gen 1 system.

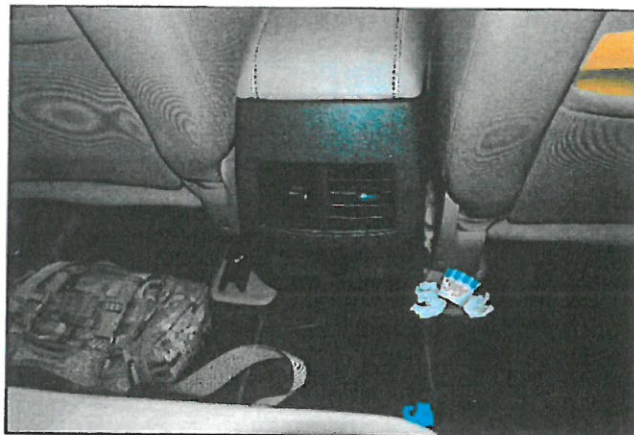
Image 3: Rear vent cover of center console.

McGill followed the module removal instructions for a Ford Edge provided by Berla. According to the instructions, the module was located at the rear of the center console, just behind the rear vent cover. However, the module was not located behind this cover. McGill contacted Berla support and learned the alternate location for the module was under the center console just behind the gear shift. Berla did not have specific instructions for the Ford Edge, but provided instructions for a similar vehicle.

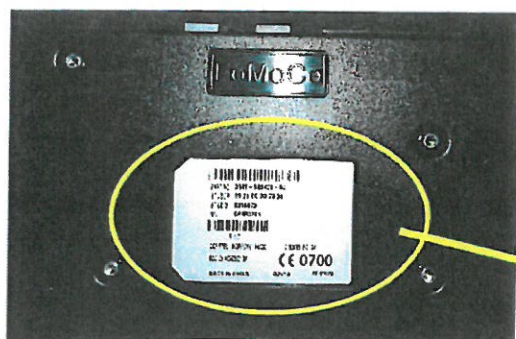
Image 4: SYNC Gen1 module from Ford Edge.

At approximately, 11:30 a.m., the module was removed from the vehicle and provided to Frizzell. McGill confirmed the SYNC Gen1 module by the label on the case.

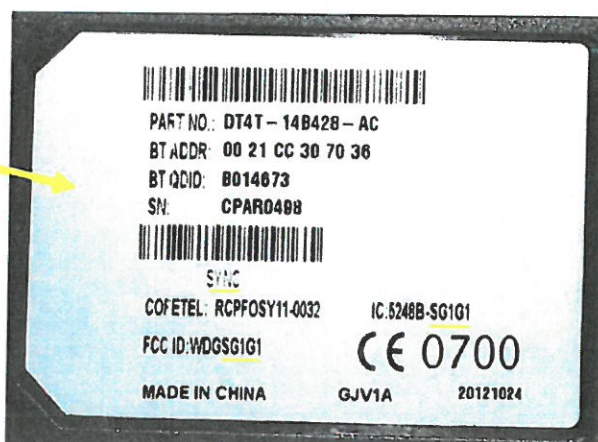
Image 5: Close-up view of label from module.
